Manhole Inspection Summary

Manhole # S33G__019MH

Insp Date: **12/15/08 11:17 AM**

Location Address: **201 hopkins place** Cross Street: **e. baltimore st**

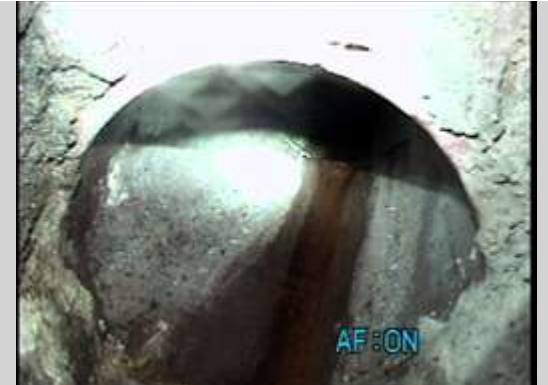
12 O'Clock Outflow

8 in. Circular Gravity Sewer
Pipe Out @ 12 O'Clock

Pipe Material: Clay ☐ Pipe Lined

Invert Depth: 17.33 (ft.) Flow Characteristics: None

Deposits: ☒ None ☐ Mud ☐ Sludge ☐ Debris ☐ Grease

Infiltration: None Pipe Seal Cond: Unknown

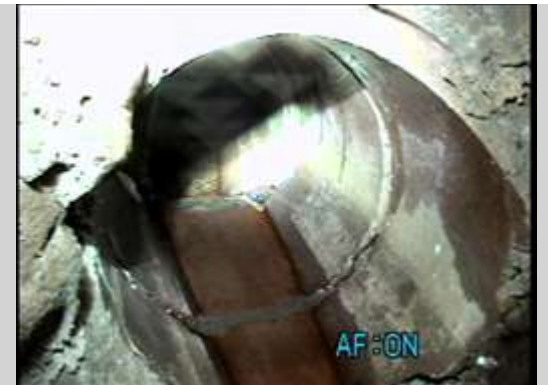
3 O'Clock Inflow

8 in. Circular Gravity Sewer
Pipe In @ 3 O'Clock

Pipe Material: Clay ☐ Pipe Lined

Invert Depth: 17.20 (ft.) Flow Characteristics: None

Deposits: ☒ None ☐ Mud ☐ Sludge ☐ Debris ☐ Grease

Infiltration: None Pipe Seal Cond: Unknown

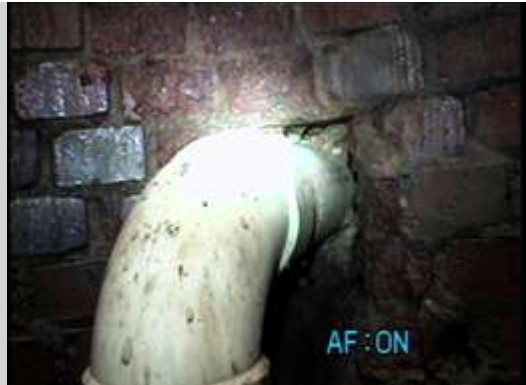
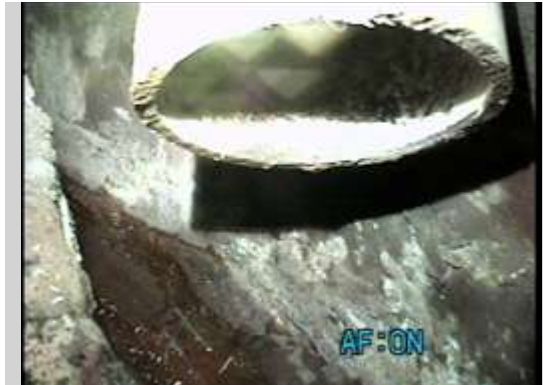
5 O'Clock Inflow

6 in. Circular Gravity Sewer

Pipe In @ 5 O'Clock

Drop In @ 5 O'Clock

Pipe Material: **PVC** ☐ Pipe Lined

Invert Depth: **5.80** (ft.) Flow Characteristics: **None**

Drop: **Inside** **Direct**

Drop Condition: **Open**

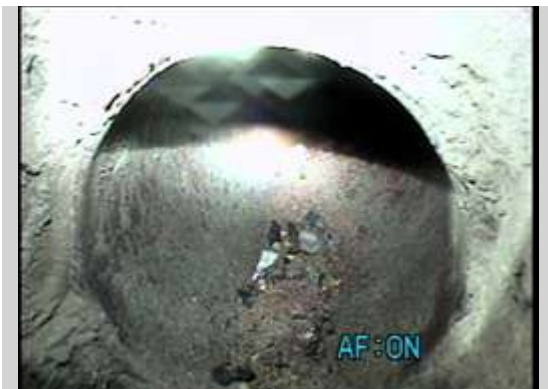
9 O'Clock Inflow

8 in. Circular Gravity Sewer

Pipe In @ 9 O'Clock

Pipe Material: **Clay** ☐ Pipe Lined

Infiltration: **None**
